The Importance of visual Examination in the Failure Analysis: Case History of a Microbiologically Influenced Corrosion

In this paper we present a case of microbiologically influenced corrosion interesting several stainless steel storage tanks of a sugar Refinery.

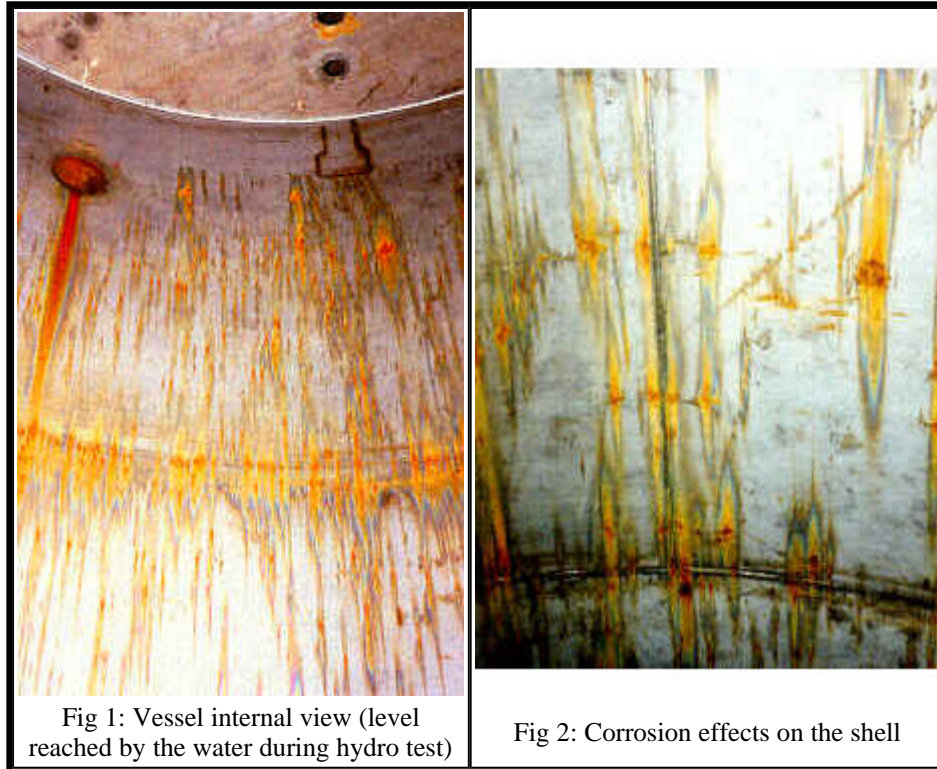
The surfaces affected by corrosion phenomena were located between a top line at 30÷80 cm from top cover and the circumferential seam connecting shell to bottom (Fig. 1 and 2).

The aspect of the corroded areas is generally similar to two vertical compass needles (streaks) having the edges in opposite positions and having the core-origin of pitting corrosion - in correspondence of the top edge of circumferential seams.

Additional vertically pitted areas have been visualized in correspondence of superficial incisions, welding circumferential joints and welding anomalies.

- a. Top borders of areas including corroded surfaces corresponded exactly to the highest level reached by water during hydrostatic test of vessels.
- b. In the upper parts of the shells (from the highest nozzle up to cover plate) the surfaces were clean and integer.

1. Soft grinding of all corroded areas by stainless steel grinding disk.
2. Application of pickling-passivating paste.
3. Rinsing of the surfaces using demineralized water properly treated. Water injected onto the plates with a H.P. water launcher.
4. Final controlled drying of the surfaces by blowing air with an air fan.

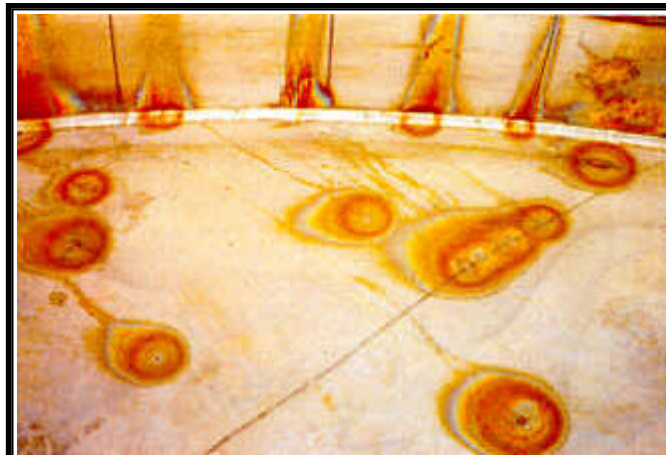
The areas affected by pitting corrosion phenomena (Fig. 3 and 4) were spread at random on the plate of the bottom head. They were covered by corrosion deposits having a crest in correspondence of the origin of pitting; the average diameter of corroded zones was about 50 mm; the central height of the pit was in the range of 1÷3,5 mm.

Fig 3: Corrosion effects on the bottom

1. Grinding(as previous paragraph).
2. Checked drilling of pits around their central points by using stainless steel drills as follows:

3. Filling the ground areas with additional metal using approved welding procedure.
4. Grinding of surplus welding materials.
5. Dye penetrant liquid examination of weldings.
6. Pickling-passivation (as in previous paragraph).
7. Rinsing (as in previous paragraph).
8. Final drying (as in previous paragraph).

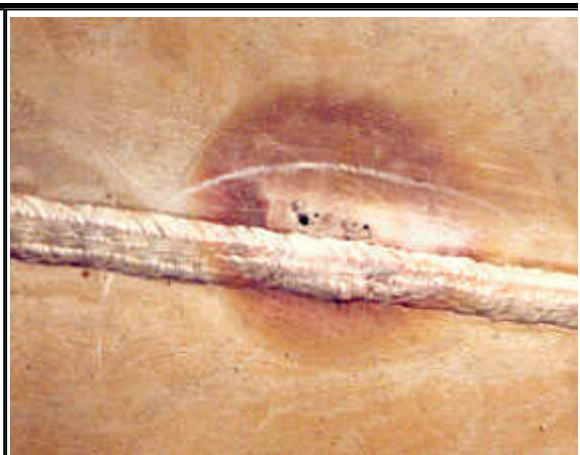
Fig 4: Detail of a pit near the bottom weld

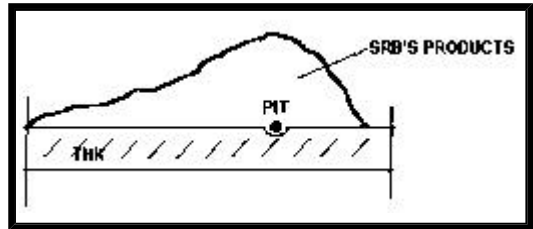
growth of moving microbacteria ("biological corrosion"). The progressive superficial accumulation of deposits (see the following sketch) indicated the presence of Sulphate Reducing Bacteria (SRB):

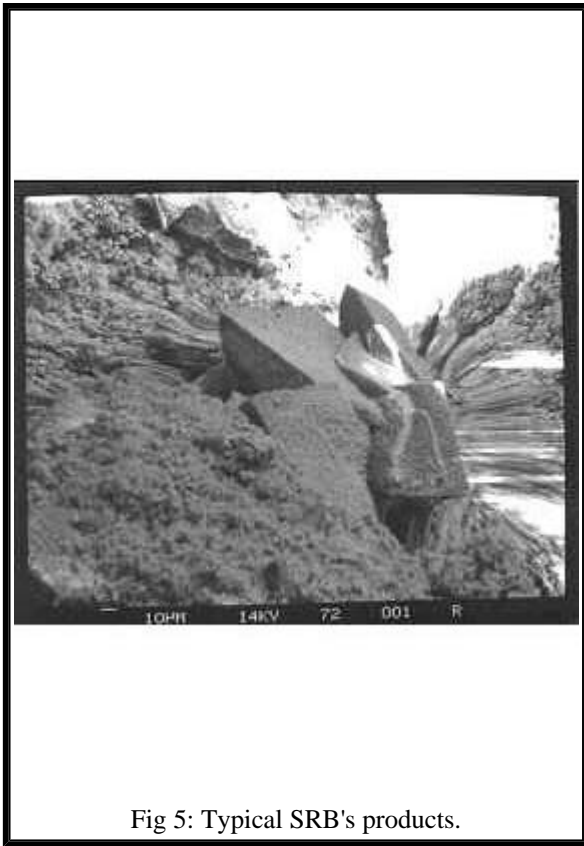
Fig 5: Typical SRB's products.

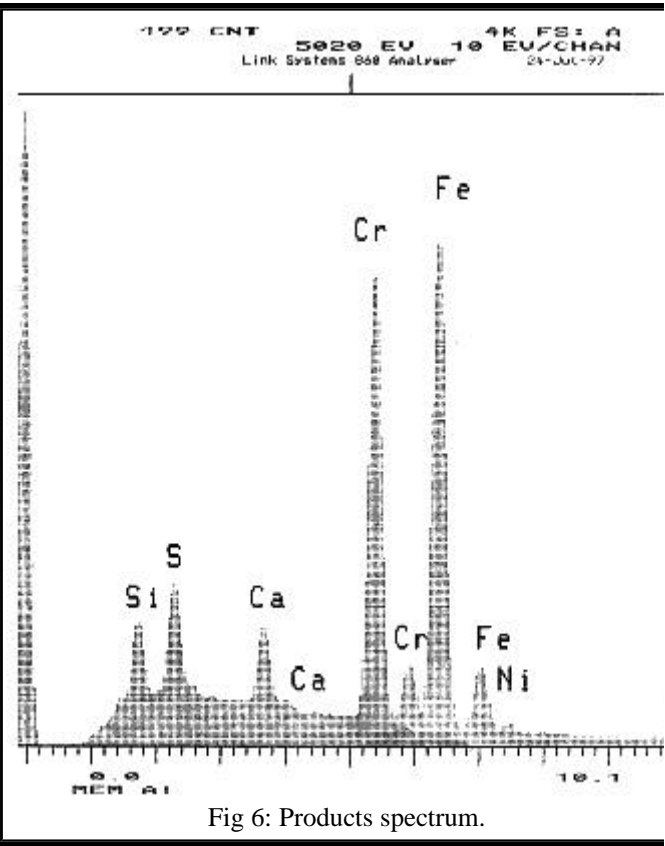
Fig 6: Products spectrum.
